Fractography of compression failed carbon fiber reinforced plastic composite laminates

M. S. Vinod^{1, 4*}, Sunil B. J¹, Vinay Nayaka¹, Raghavendra Shenoy^{1, 4}, M. S. Murali² and A. Nafidi³

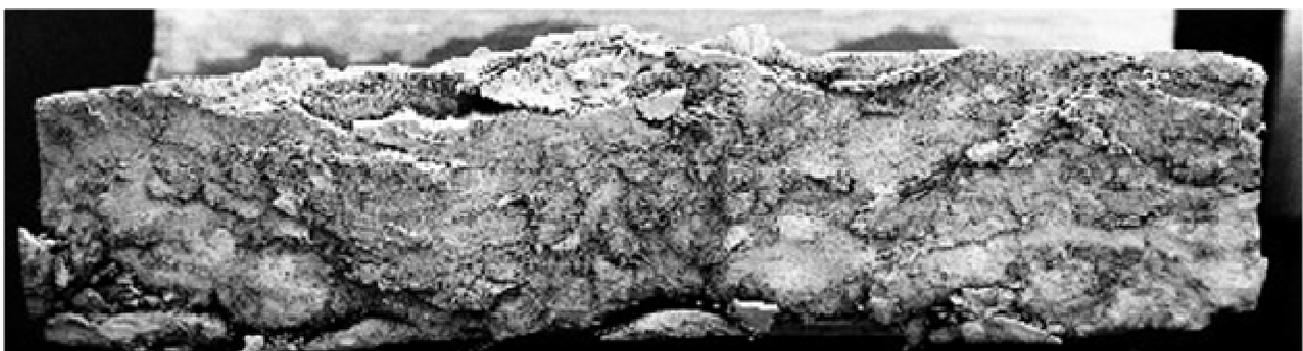
The predominant macroscopic failure mode has been identified as shear crippling, which looks like a shear failure (Figure 3). Microscopic inspection, however, indicates that shear crippling is frequently the result of kink-band formation (Figure 4). This shear crippling in composites resembles slip lines in metals. SEM examination of the fracture surface revealed stepped structure at different locations as shown in Figure 5a and b. It has been observed that the micro-buckling/kinking (damage zone), which is the formation of reoriented material bands on a plane at some angle to the direction of loading (Abrate, 1991; Zsigmond and Vas, 2006), spreads over several fibers and consist of several crushed and angled breaks, occurs on several planes and the overall fracture surface sometimes consists entirely of series of steps, the height of each step being a multiple of half the buckling wavelength (Lemascon et al., 1996). Local fiber buckling/kinking and fiber fractures leads to an irregular, stepped fracture surface. This is a characteristic feature of compression failure that is failure of the fibers by micro-buckling/fiber kinking (Figure 5c).

Figure 3. Fracture surface of compression failed test coupon.

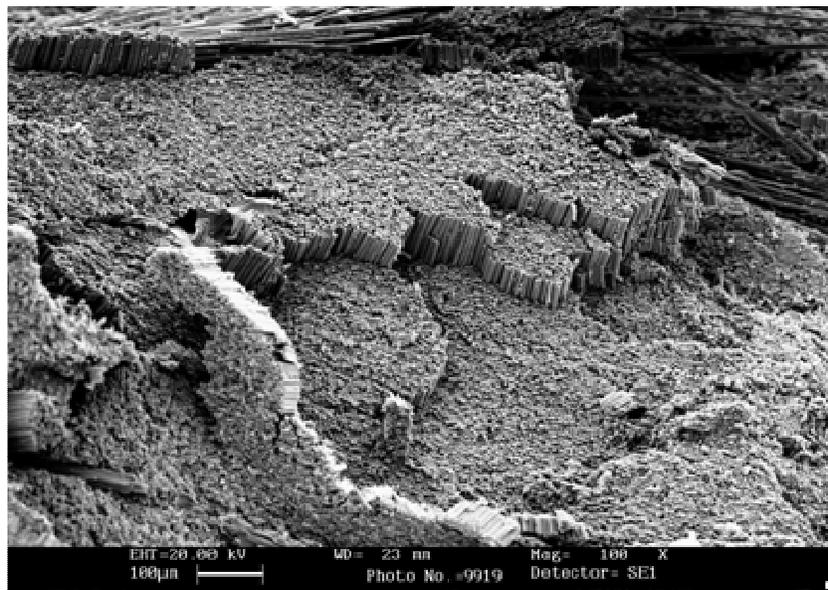
Figure 5a. Stepped fibre fracture.

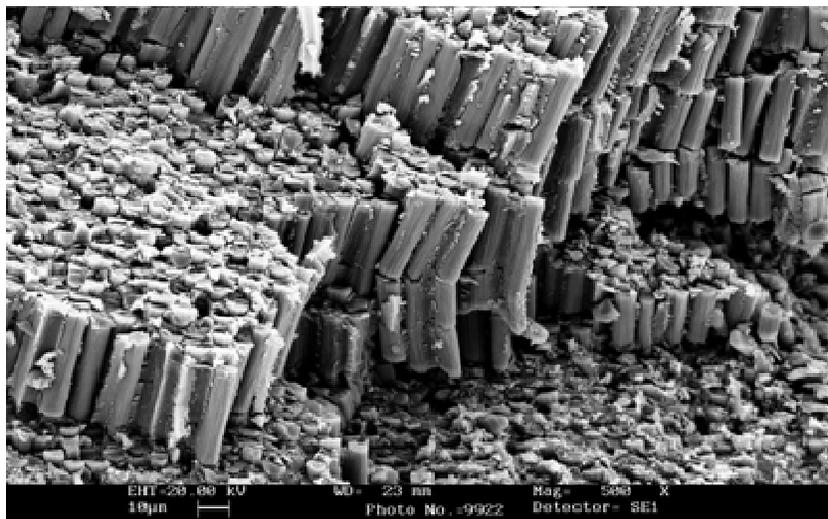
Figure 5b. Fibre fracture by micro buckling and fracture at different heights.

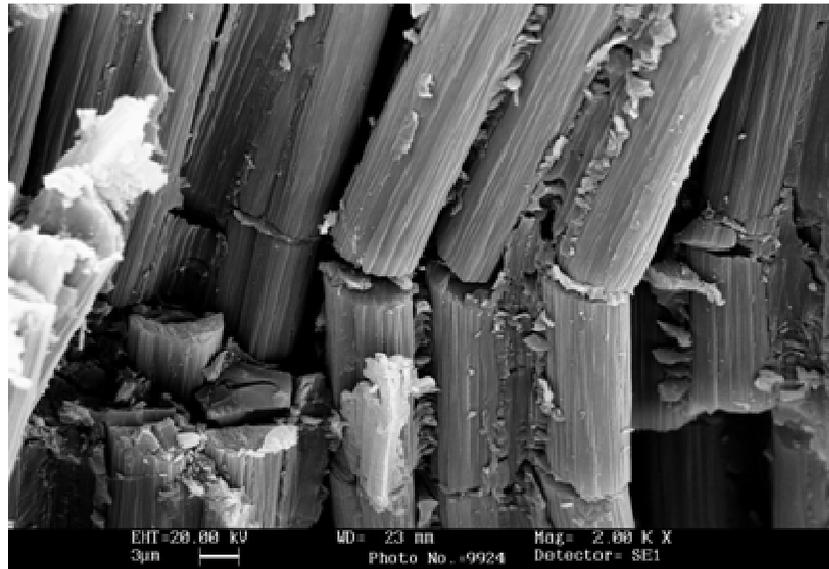
Figure 5c. Microbuckling/Kinking.

High values of fiber volume ratio, shear or in phase mode micro-buckling has been predicted (Cox et al., 1994), wherein the flexural stresses because of the in-phase buckling leads to the formation of fracture planes (Figure 5c). In Figure 5d, a typical compressive failure feature - Chop marks is observed. At high magnifications in Figure 5e, the fracture surface of the individual fibers showed two distinct areas of smooth compressive and rough tensile areas separated by neutral axis (NA), known as chop marks, where its showing clear evidence of compressive failure from Compression side (C) to the NA and a tension failure from Tension side (T) propagat-

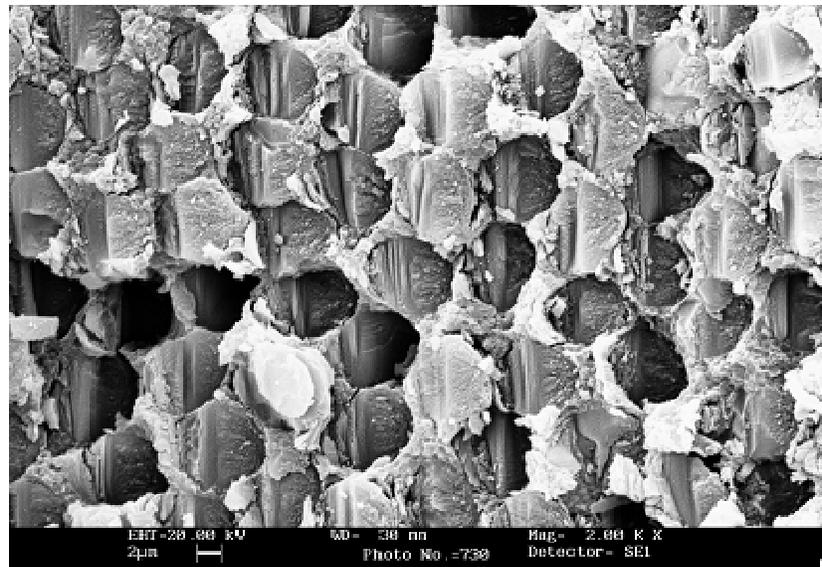
Figure 5d. Chop marks typical of failure under compressive load.

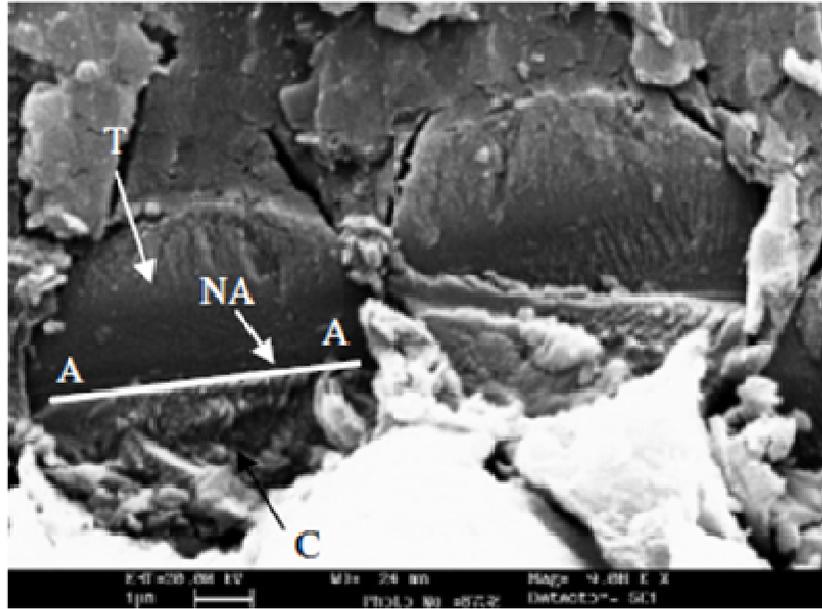
ing to the NA. It may also be noted that a strong bond between fiber and matrix is present in (Figure 5e) and also the matrix and fiber debris have been observed, which are characteristic of compression failed samples. Most of the fracture surface features were obliterated due to abrasion of mating fracture surfaces during failure that is post-failure movement of the mating surfaces has caused abrasion over most of the fracture. And in Figure 5f, clearly neutral axis (buckling axis) can be observed and the local crack propagation direction is in the direction perpendicular to it. And the crack propagation is through the thickness. The crack propagates to fracture,

Figure 5e. High magnification fractograph showing chop marks separating tension and compression by neutral axis.

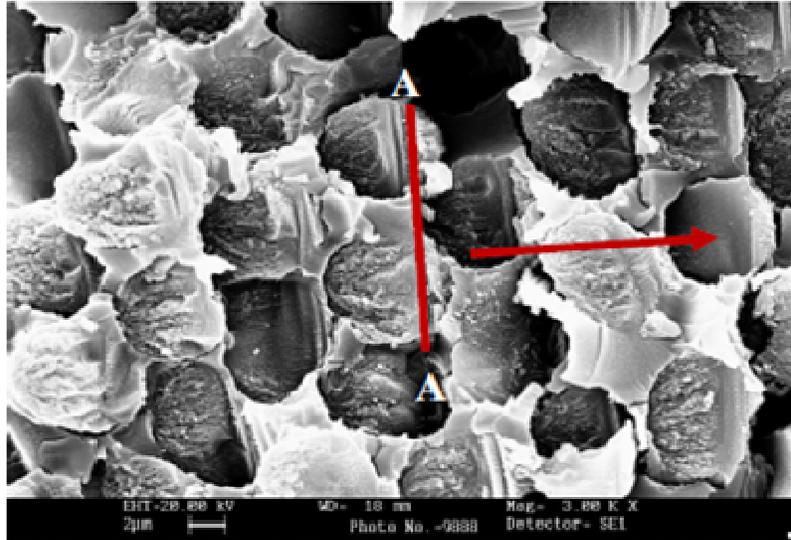
through the individual fibers from the tensile to the compressive side in a direction perpendicular to neutral axis/buckling axis (A-A). Also, the fracture direction and height common to all the fibers in a step indicate localized crack propagation. Thus, the buckling axis (Figure 5f) can be used for determination of the local crack propagation direction and hence identification of the failure origin. Detailed examination of the fractographic features revealed identical local crack propagation direction at most of the preserved regions. Therefore, it was possible to use relative position of the compressive/tensile facets of the individual fiber in determination/mapping of the overall crack propagation direction for the sample under study (Figure 6).

Figure 5f. Local crack propagation direction indicated by an arrow perpendicular to neutral axis AA.

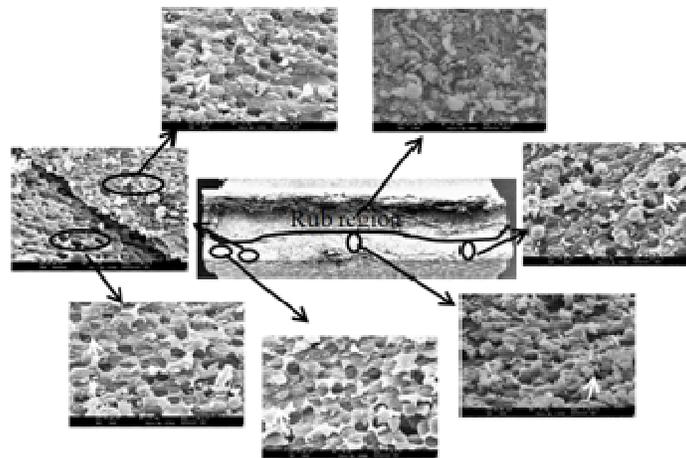
Figure 6. Map of overall crack propagation direction.
