## Assessment of environmental hazards: Linking borrow pits, gully erosion, and road failure

Highway failure linked to the action of erosion initiated by active or abandoned borrow pits in no small measure affects environmental quality and safety. This study has investigated the Owerri-Okigwe-Enugu highway, Nigeria. Environmental assessment of the study area through photographs showed prevalence of landslides, at risk structures, and motor accidents. Soil samples were collected at three abandoned borrow pits at Ihube, Leru and Ngeru for laboratory tests, while three surface electrical resistivity measurements were conducted to understand the subsurface complexity of the area. Average values are 2.05 mg/m<sup>3</sup> (MDD) and 12.96% (OMC) of the three locations. The soil is non-plastic, and non-cohesive. Particle size analysis confirms the soil as sandy, thus easily erodible and not a suitable road fill material. Resistivity measurements showed presence of underlying shale sequence which continues below 88 m, with 5.05 m as average depth of overburden. This near surface shale accounts for the frequent failure of the highway. Factor of safety and probability of sliding is affected

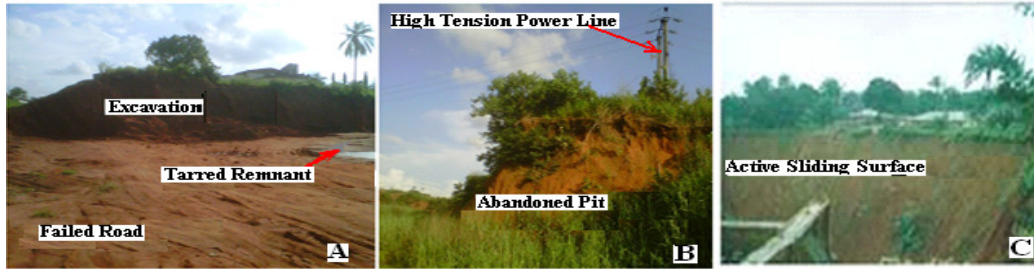
Figure 4. A. Road failure B. Surface about sliding C. Homes about sliding.

Figure 4a-c, shows significant environmental hazards along sections of the highway under investigation. Figure 4a shows road failure that has for several years remained death trap to commuters. On top of one of the abandoned borrow pit at Owerri Okigwe highway is a high tension electric pole (Figure 4b). From the crest of the slope to the high tension pole is about 10 m. There is a thick vegetation cover of bamboo trees which have stabilized the soil from sliding. But that does not guarantee safety of the pole under heavy rains. The high tension pole poses a lot of environmental hazards to the residents and commuters. With increase in rainfall, infiltration will weaken the soil, creating tension cracks that become planes of failure. The hazard implications of landslide affecting high tension power lines are enormous and could lead to paralysis of industrial activities for communities in the affected areas. People may be electrocuted, resulting in mass death. Figure 4c shows some residential homes at the verge of sliding.

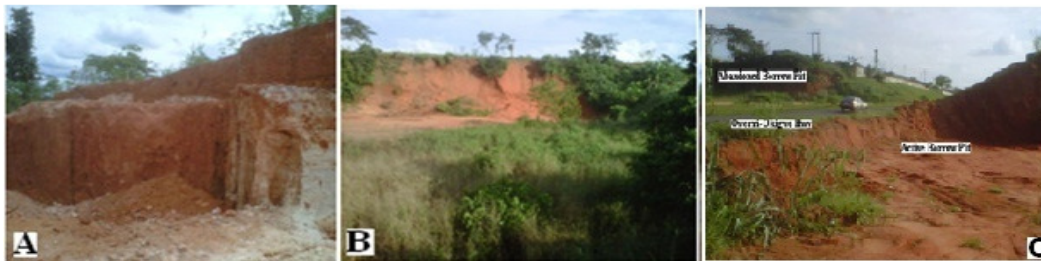
Figure 5. A: Borrow pit at Ihube B: Abandoned pit C: Roadside excavation.

Figures 5a to c, are active and abandoned pits showing different soil texture. The sandy variegated color of

Figure 5a is typical of the Ajali sand Formation escarpment traversing the Okigwe-Enugu highway.

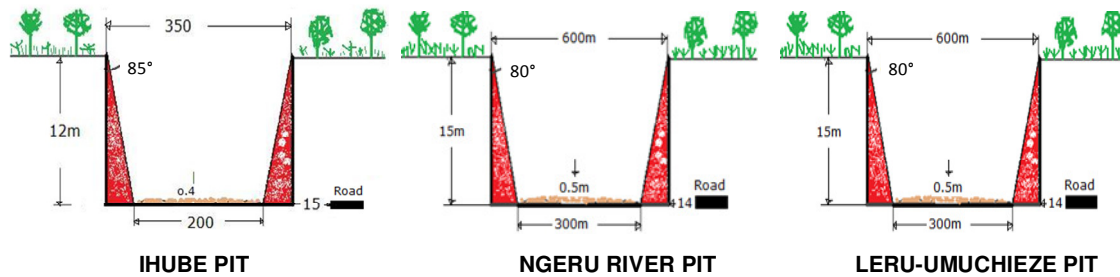
Figure 6. Geometry of the borrow pits.

Figure 6 is a graphical illustration of the pits geometry from direct field measurements. The pit at Ihube, Limca company junction has the following coordinates and elevation North (05° 51' 802) East (07° 21' 360) and an elevation of 708ft. Ngeru River pit has the following coordinates: North (05° 45' 904) East (07° 14' 675) and elevation of 400ft. The third pit situated at Leru Umuchieze Umunneochie has the following coordinates: North (05° 45' 904) East (07° 14' 675) and an elevation of 708 ft. The 80° to 85° pit wall angle significantly indicate great tendency to sliding. Increased water saturation at peak of rain season creates planes of weakness where movement occurs often in form of slump.

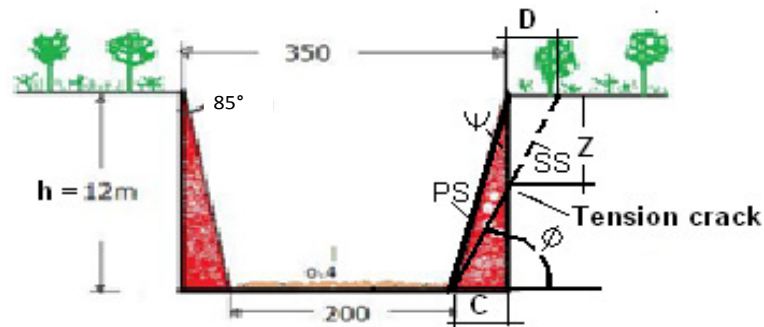
Figure 7. Analytical illustration of factor of safety and probability of sliding.

The classical approach used in designing open pit excavation is to consider the relationship between force resisting sliding (C) possessed by the base rock and the overburden pressure (D) initiating sliding. The Factor of Safety (F) of the pits is defined as  $F = C/D$  (Figure 7) and failure is assumed to occur when F is less than unity.

If D is the distance of tension crack from pit crest, the less the distance, the greater is possibility of sliding.

$\psi$  = Pit slope angle (80 to 85°) when reduced, enhances slope stability.

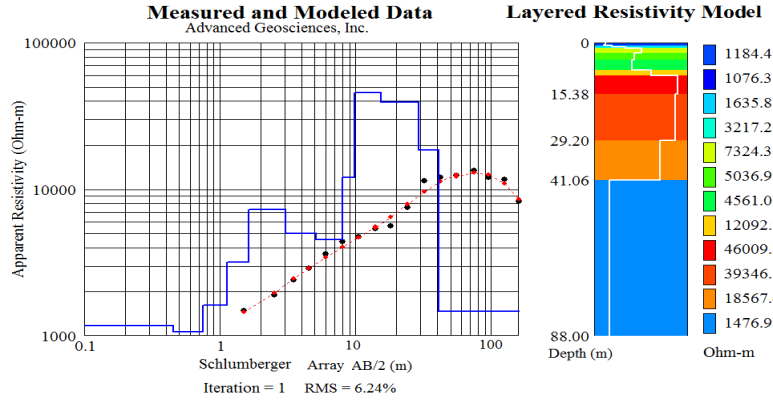
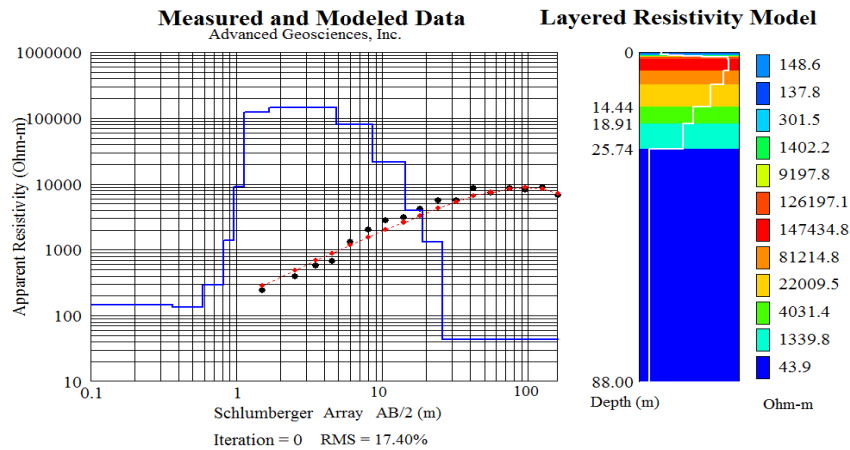
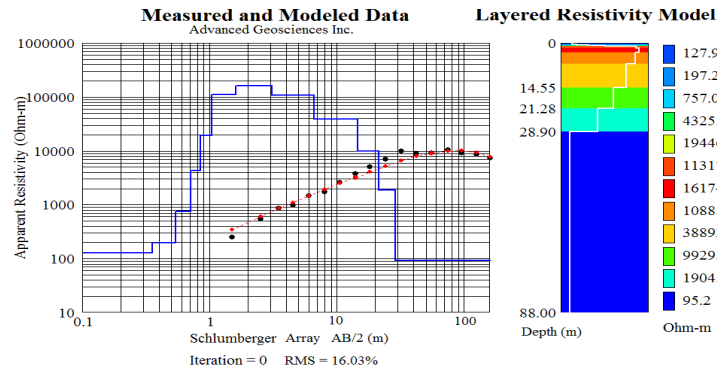
Figures 8 to 10 show the VES curves as constrained to the specified number of geo-electric layers. The various layers are differentiated by color code, with lithology,

results generally present the subsurface geology of the area as predominantly shale units, capable of causing frequent road failure. Generally, the VES result shows near surface lithology consisting of shale, siltstone, silty-sand and clay units to an average depth of 8 m. These

materials are not suitable as base material for road construction. These materials have tendency to swell when wet, and to shrink when dry causing road failure irrespective of the quality of road fill material used.

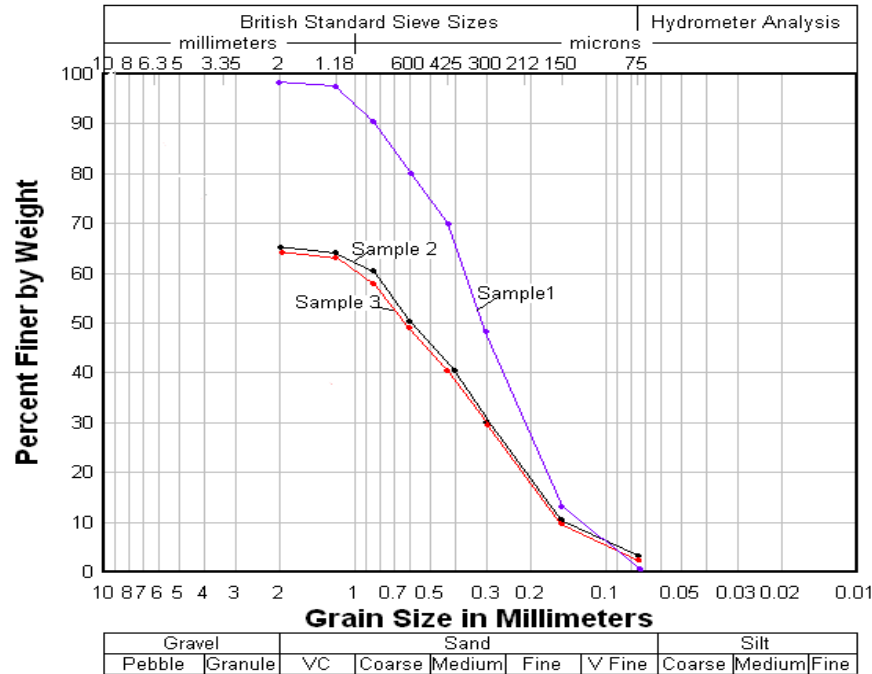
Figure 11. Grain size distribution curves of the three soil samples.

Analysis of grain size distribution of the respective soil samples is shown in Figure 11. Ihube (Sample 1): 2.5% Gravel, 96.5% Sand while Silt and Clay is negligible. Ngeru (Sample 2): 3.3% Gravel, 94.3% Sand while Silt and Clay content is also negligible. Leru-Umuchieze

(Sample 3): 7.7% Gravel, 57.7% Sand and Fines (Silt and Clay) is 34.1%. From the result it shows that the soil samples at Ihube and Ngelu crossing contain mainly sand, little gravel and no fines. The samples at Leru Umuchieze contain applicable quantities of Gravel, Sand and Fines.

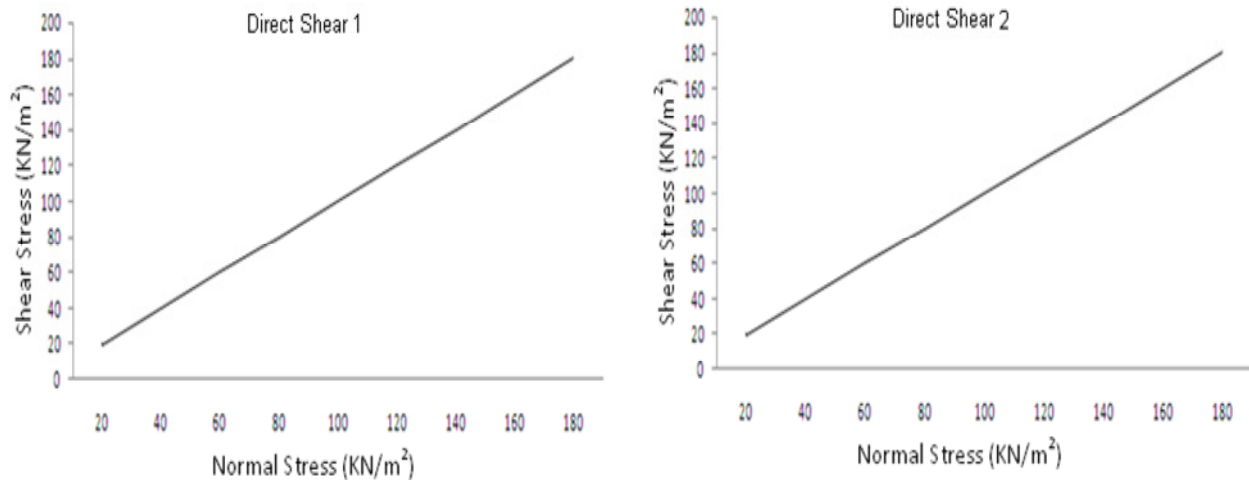
Figure 12. Shear stress versus Normal Stress.

Direct shear test (Figure 12) shows that the soil samples are cohesionless. This implies that they are easily eroded and can be transported from one location to another in

the form of landslide and gully erosion. From the result, it shows that the soil structure in the study area is poor, accounting for the series of road failures.

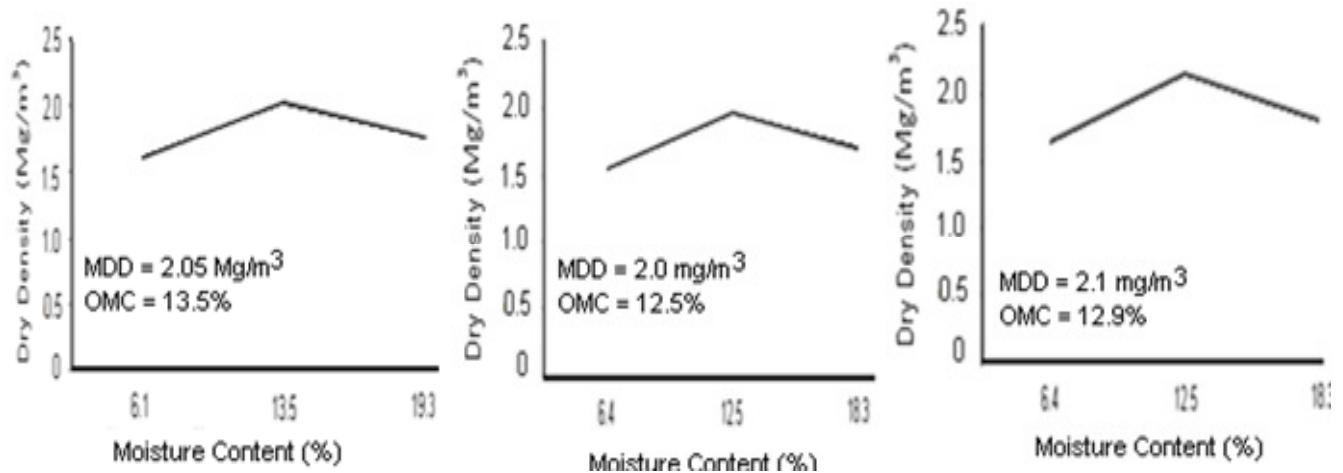
Figure 13. Graph of dry density vs. moisture content (%);

samples collected from the pit indicate that for Test 1 (Ihube): M.D.D = 2.05 Mg/m<sup>3</sup>, O.M.C = 13.5%; Test 2 (Ngelu River): MDD = 2.0 Mg/m<sup>3</sup>, O.M.C = 12.5%; Test 3 (Leru-Umuchieze): MDD = 2.1 Mg/m<sup>3</sup>, O.M.C = 12.9%. From the result analysis it shows that all the soil samples collected at the different borrow pits sites were non plastic (NP). This means that the plasticity index of the soil is zero. It also means that the plastic and liquid limits

cannot be determined by standard procedure (Head 1984). Since the soils are non-plastic, they are likely to have higher permeability.
