# Wood-destroying Coleopteran species in the historical buildings in Kastamonu, in Turkey

The aim of this study is to identify the harmful insects causing damage in the historical wooden buildings of Kastamonu. Accordingly, 15 of those historical wooden buildings situated in the city were periodically controlled between the years 2002 and 2005. During those periodic controls, damages caused by insects were detected and additionally, dead and alive insects were collected from the damaged materials. As a result of this study, 7 species from 4 families were identified; these species are *Anobium punctatum* De Geer, *Xestobium rufovillosum* De Geer, *Ernobius mollis* (L.), *Ptilinus pectinicornis* (L.) (Anobiidae), *Lyctus brunneus* (Steph.) (Lyctidae), *Hylotrupes bajulus* (L.) (Cerambycidae) and *Rhizophora* sp. (Bostriichidae). Except *A. punctatum* and *H. bajulus*, the rest are considered as the first records gathered in Kastamonu region.

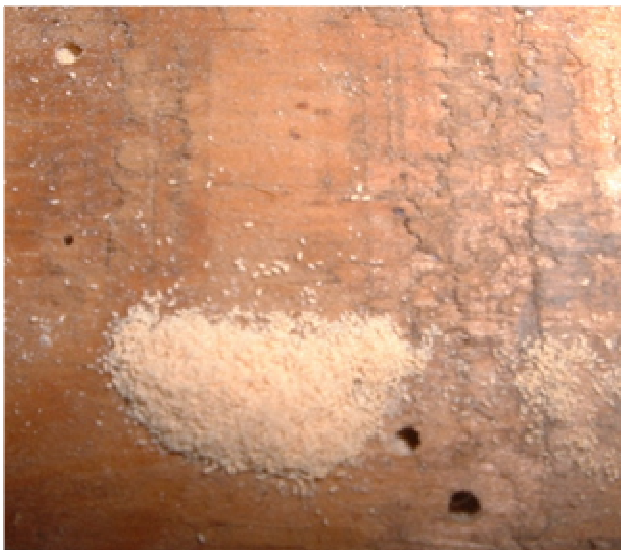
**Figure 1.** Small pile of dust accumulates near exit holes of *A. punctatum* in the wood.

*domesticum* (Geoffroy, 1785) and *A. striatum* Olivier, 1790. This damaging insect was detected in various parts of entrances and rooms of buildings and mainly located in carved boards, in-built bathrooms and wooden ornaments, stair carvings, shelves in kitchens, windows and frames (Table 2). An adult one was noted on the feet of a handmade piano made of walnut tree, at 75, Cumhuriyet House. In addition to this, 78 entry and exit tunnels were observed on a 10 cm × 10 cm piece of shelf obtained from the Mansion of Haci Tahir Efendi. It was observed that a yellow-like frass or powdered wood poured out of exit holes in which some dead adults with their heads turned upside were found near the edges. The damage caused by this insect was the building of parallel short tunnels near the surface of the wood, filled with yellow-like frass or powdered wood. The diameter of exit tunnels ranged from 1 - 1.2 mm (Figure 1).

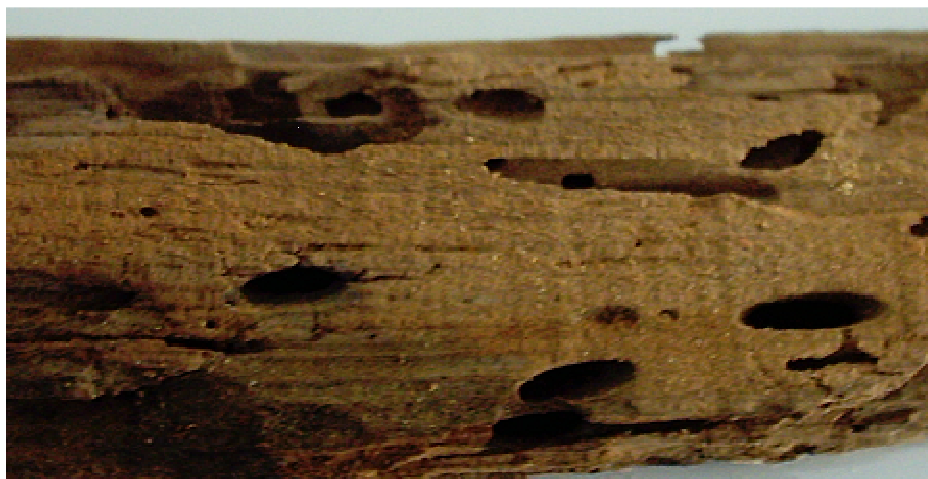
**Figure 2.** Damage of *L. brunneus* (Steph.).

Synonyms: *Lyctus disputans* Walker, 1701; *L. costatus* Blackburn, 1888 -*Xylotrogus brunneus* Stephens, 1830. This insect was detected in the exit tunnels of a wooden log in Vedat Tek Restoration Centre during daytime. A pile of tiny dark yellowish frass or sawdust poured out of the circular shaped exit tunnels that was 1.2 to 1.8 cm in diameter. The surface of the sample log was untouched, yet the part under the surface was covered with long, parallel and connected holes that seemed to be the remnants of rat damage (Figure 2). They feed primarily on hardwoods (Table 3).

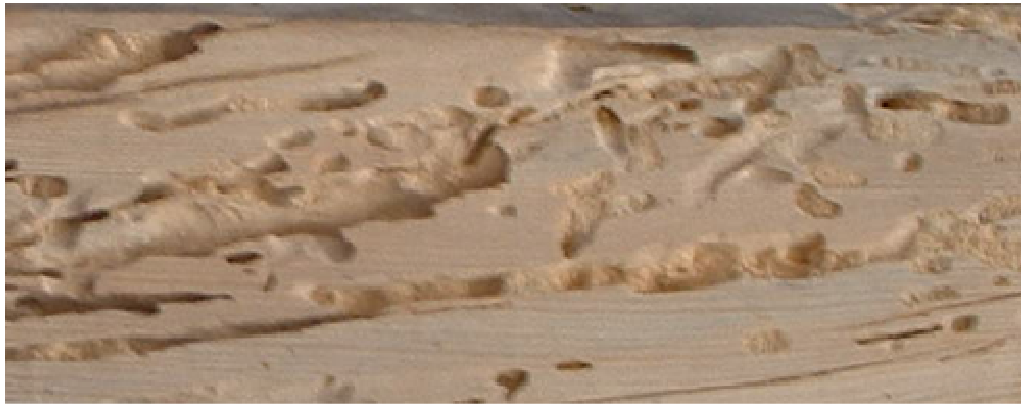
in wooden beams, floorings and roofs. The sound and solid parts of the wood affected were completely spoiled. When examined outside, the entry holes could be seen whereas insect damage was not apparent. The exit holes were similar to the ones of *L. brunneus* and the excavated tunnels which were oval shaped, short and interrelated led to the deeps of the logs (Figures 3, 4 and 5).

**Figure 3.** Damages of *H. bajulus* (L.).

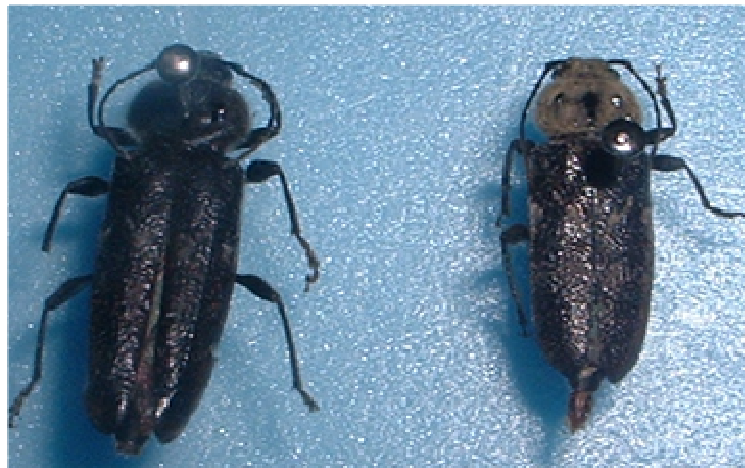
**Figure 4.** Adults of *H. bajulus* (L.).

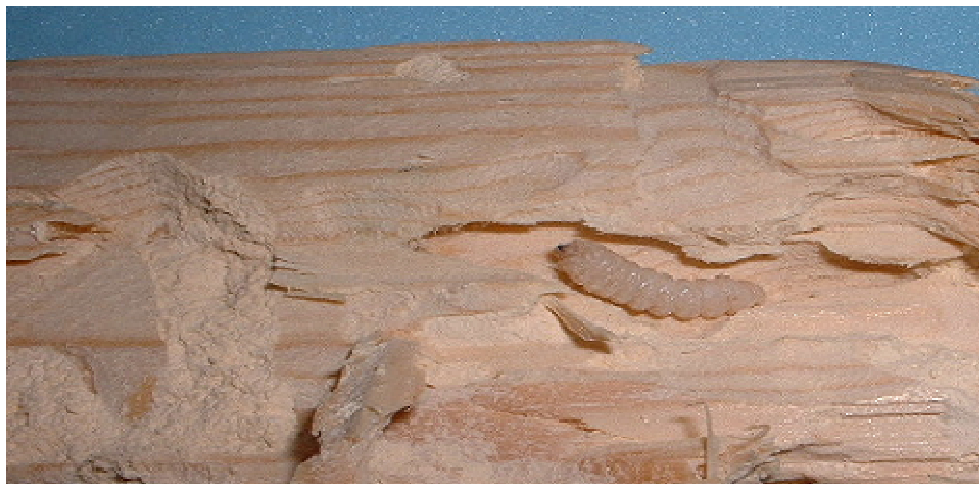
**Figure 5.** Larva of *H. bajulus* (L.).
