Fractography of compression failed carbon fiber reinforced plastic composite laminates

M. S. Vinod^{1, 4*}, Sunil B. J¹, Vinay Nayaka¹, Raghavendra Shenoy^{1, 4}, M. S. Murali² and A. Nafidi³

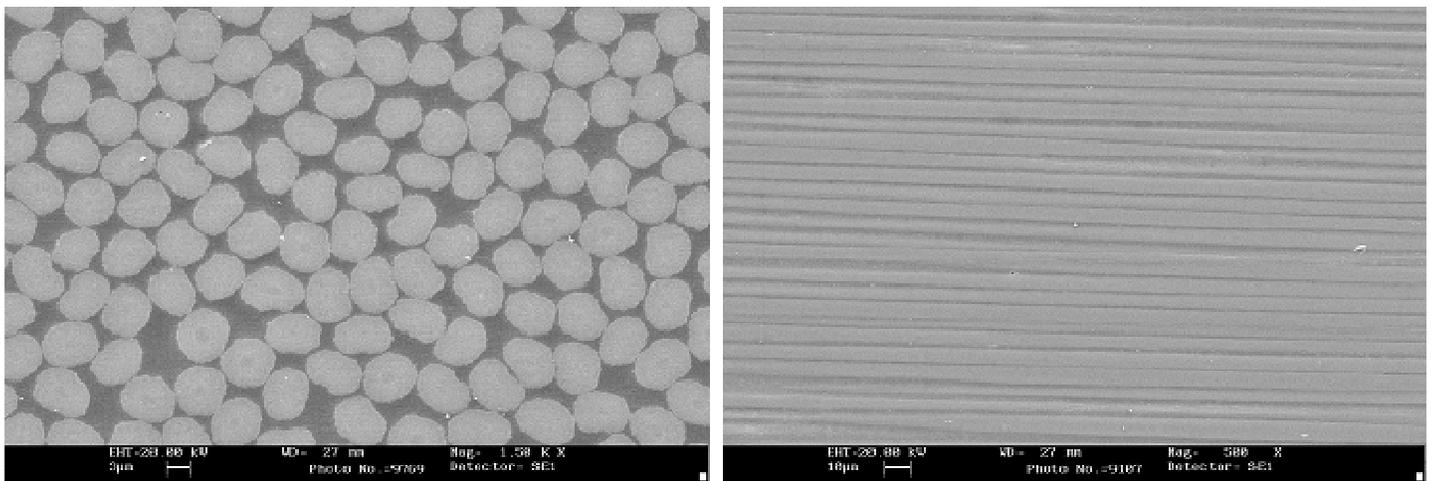
The CFRP samples were tested for its longitudinal and cross sectional morphology, because the mechanical properties of unidirectional carbon/epoxy prepreg laminates (with undamaged, well aligned fibers) against woven carbon/epoxy fabric composites differ in tensile stiffness, strength, in-plane compression, bending and fatigue properties (Cox et al., 1994; Agarwal and Broutman, 1990; Dadkhah et al., 1995). Figure 2a shows the SEM micrographs of the cross sectional uniform distribution of carbon fibers in the epoxy matrix and Figure 2b shows longitudinal distribution of carbon fibers in the epoxy matrix, indicating fairly good manufacturing process for the specimen under test as well as uniform distribution of fibers.

Figure 2. SEM micrograph showing (a) longitudinal and (b) cross sectional uniform distribution of carbon fibers in epoxy matrix.

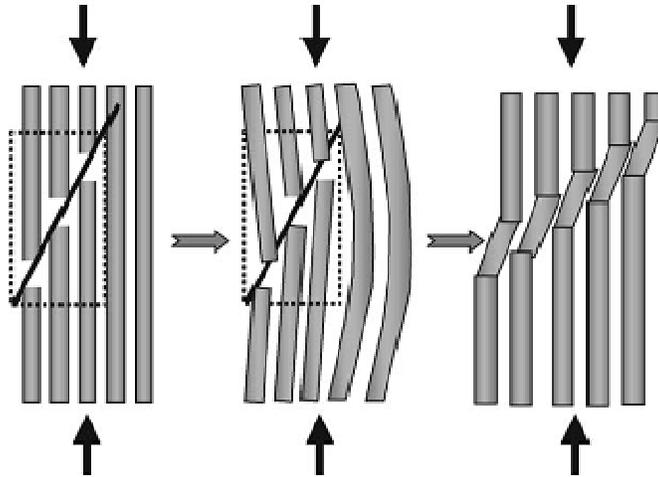
The mechanism of damage zones leading to kink bands is 'buckling of the region encompassing the damage zone', much the way a tall thin column might buckle. A schematic illustrating the possible model predicting how a damage zone could lead to kink band formation is shown in Figure 7, as suggested by (Garland et al., 2001). The damage zone grows roughly along an angle ϕ , which will predominantly depend on fiber strength and interface properties. This block of broken fibers and stressed matrix creates a weakened region with reduced load bearing capability. Also, as ϕ increases, this complaint

region, as indicated in Figure 7, becomes taller and thinner (forming a column) and thus will buckle or distort more easily under compression. The resulting rotation or distortion of this weakened columnar region ϕ would then lead to a kink band. Buckling of this column can result in micro-buckling of neighboring fibers ahead of the damage zone in two ways:

ther strain the matrix in between. This will cause surrounding fibers to bend to the point where they fracture and kink, triggering kink band formation, as shown in Figure 7. Therefore, the length scales and intensity of the over-compressed region produced by damage zones and distortion ϕ in Figure 7, will determine the critical formation stress and length scales of the resulting kink band.

Figure 7. Schematic model of the damage zone leading to kink band formation (Source: Garland et al., 2001 used with permission).
